**SACRAMENTO RIVER FLOOD CONTROL PROJECT,
CALIFORNIA
MID-VALLEY AREA, PHASE III**

**DESIGN MEMORANDUM
VOLUME I OF II**

Sacramento District
South Pacific Division

August 1995

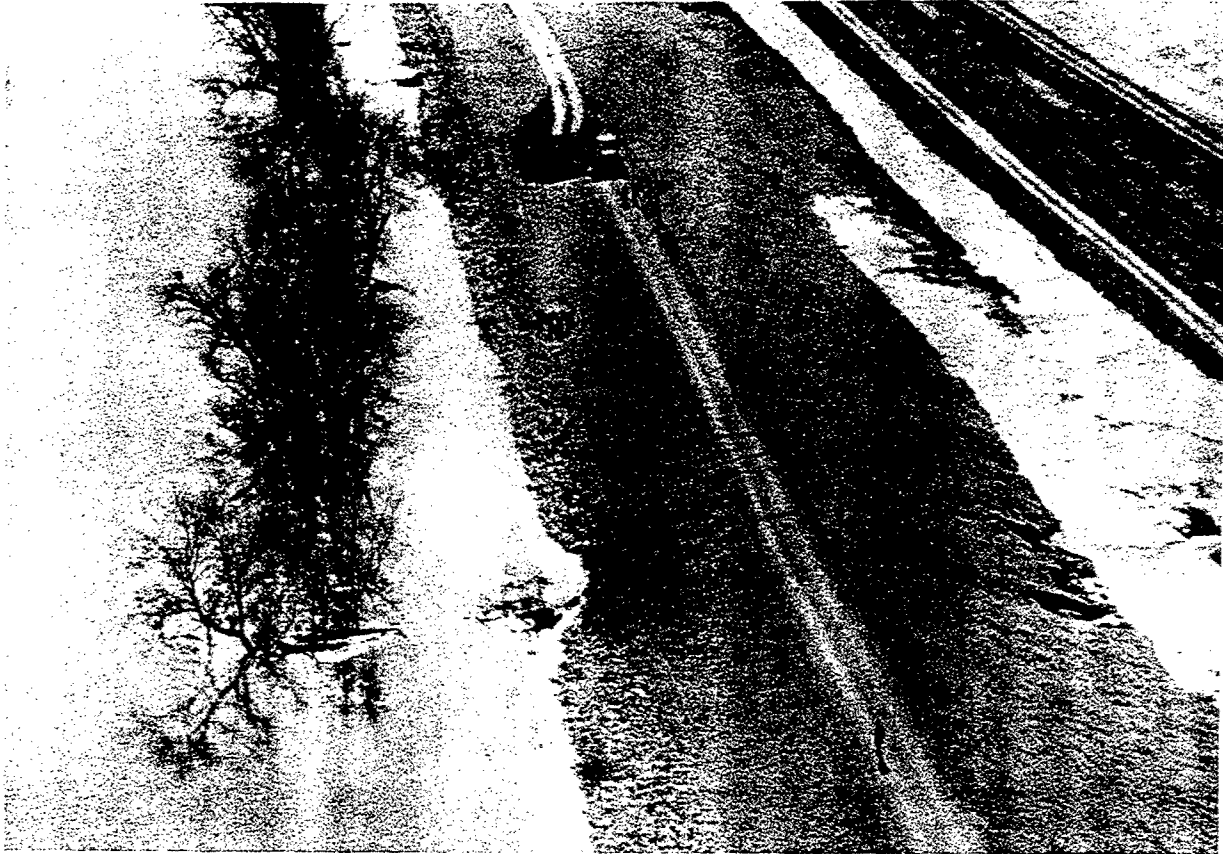
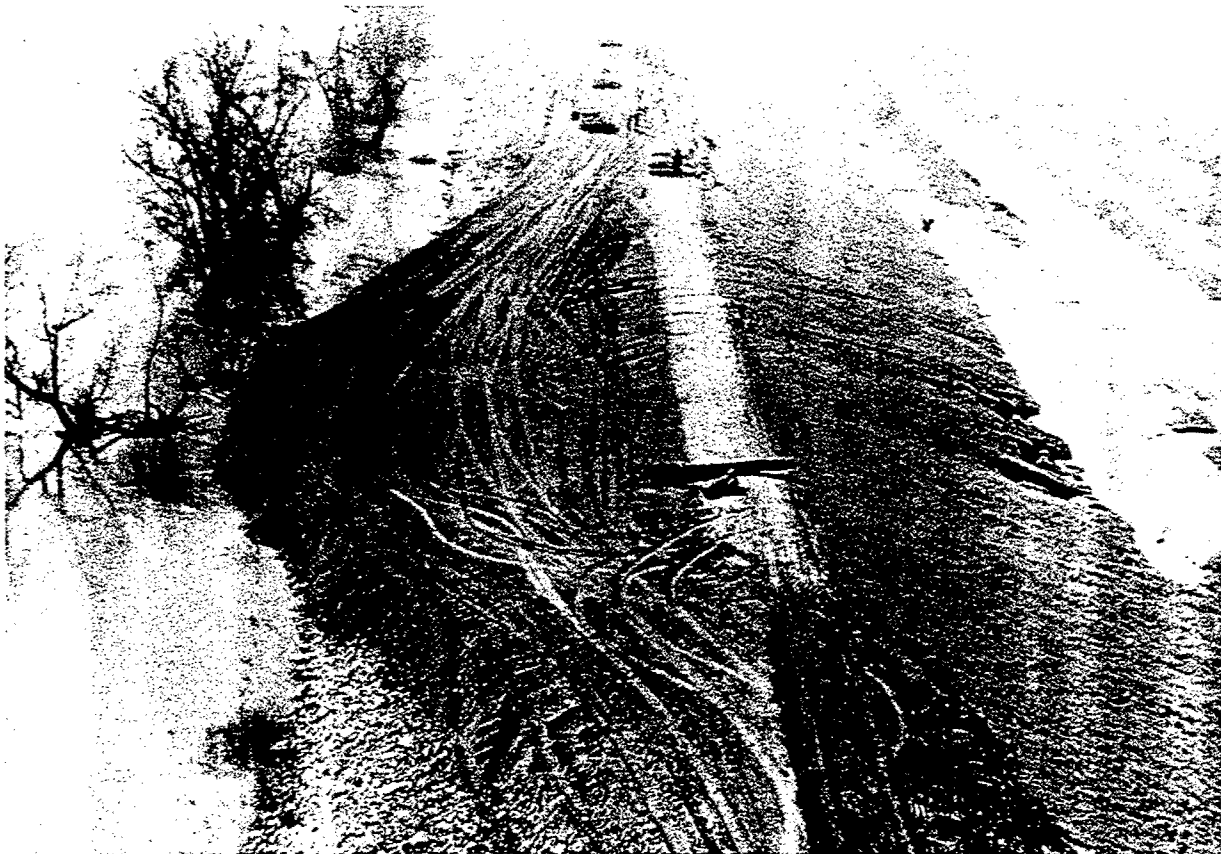
EMERGENCY FLOOD FIGHT EFFORTS ON WEST LEVEE SUTTER BYPASS
DURING FEBRUARY 1986 FLOOD.

extensive piping damage. The Robbins fire chief ordered the community of nearly 400 residents evacuated at 8:15 a.m., and evacuation was completed within an hour. Emergency flood fight efforts by the Corps of Engineers (see Figure 2) reinforced the sagging levee and probably prevented a levee break. To stabilize the levee and prevent total failure, sand and gravel were dumped on the waterside slope, creating a waterside berm about 50 feet wide and 300 feet long. Cost of the flood fight was about \$290,000. Complete levee failure was averted, but extensive damages resulted, including slumping of the levee crown, landside slope cracking, and large holes at the landside levee toe.

Sutter Bypass. - The west levee of Sutter Bypass just east of Robbins was the site of significant seepage and settlement in February 1986 (see front cover and Figures 1, 2, and 3). The problem began suddenly as a blowout of levee embankment toe material. Erosion of the landside levee toe continued until the levee embankment subsided at the site. Seepage water then appeared immediately downstream, eroding levee material until this too was stopped by settlement of the levee. The process continued downstream for about 200 feet. Emergency flood fight efforts (see Figure 2) were initiated by the Corps of Engineers to stabilize the levee embankment. A temporary waterside berm about 50 feet wide and 300 feet long was constructed of sand and gravel at a cost of about \$290,000. Upstream from this site (in the vicinity of Highway 113), numerous clear water boils have occurred along about 1 mile of levee during past high flows. Two of these boils, identified as boil numbers 12 and 16, have occurred regularly enough to have acquired numbers

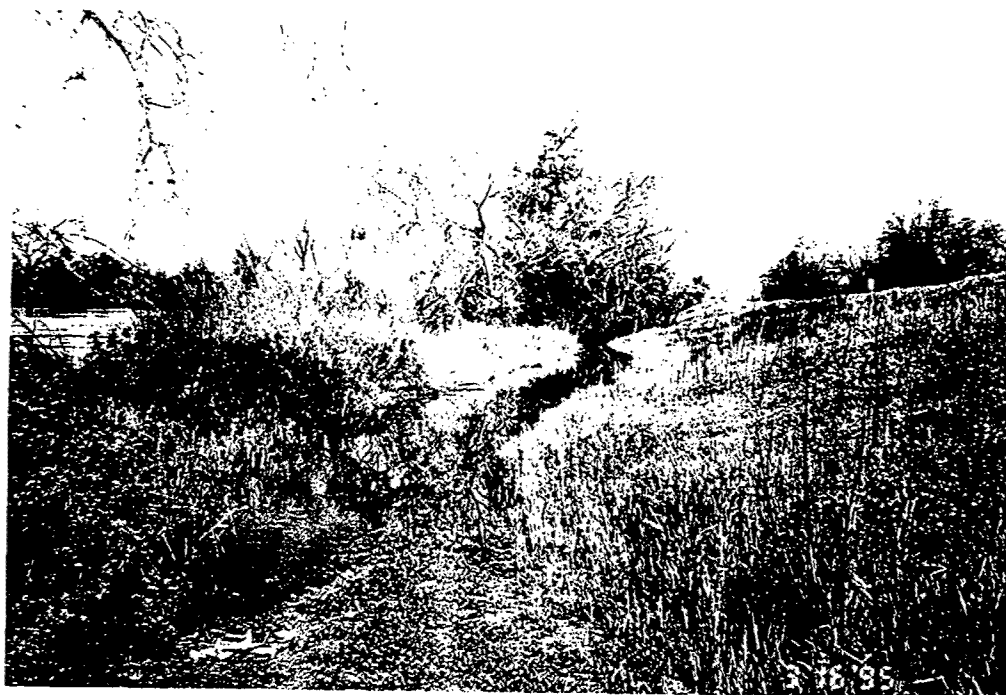
SITE 17 WATERSIDE VIEW MARCH 16, 1995
OPPOSITE OLD LEVEE BREAK POND.

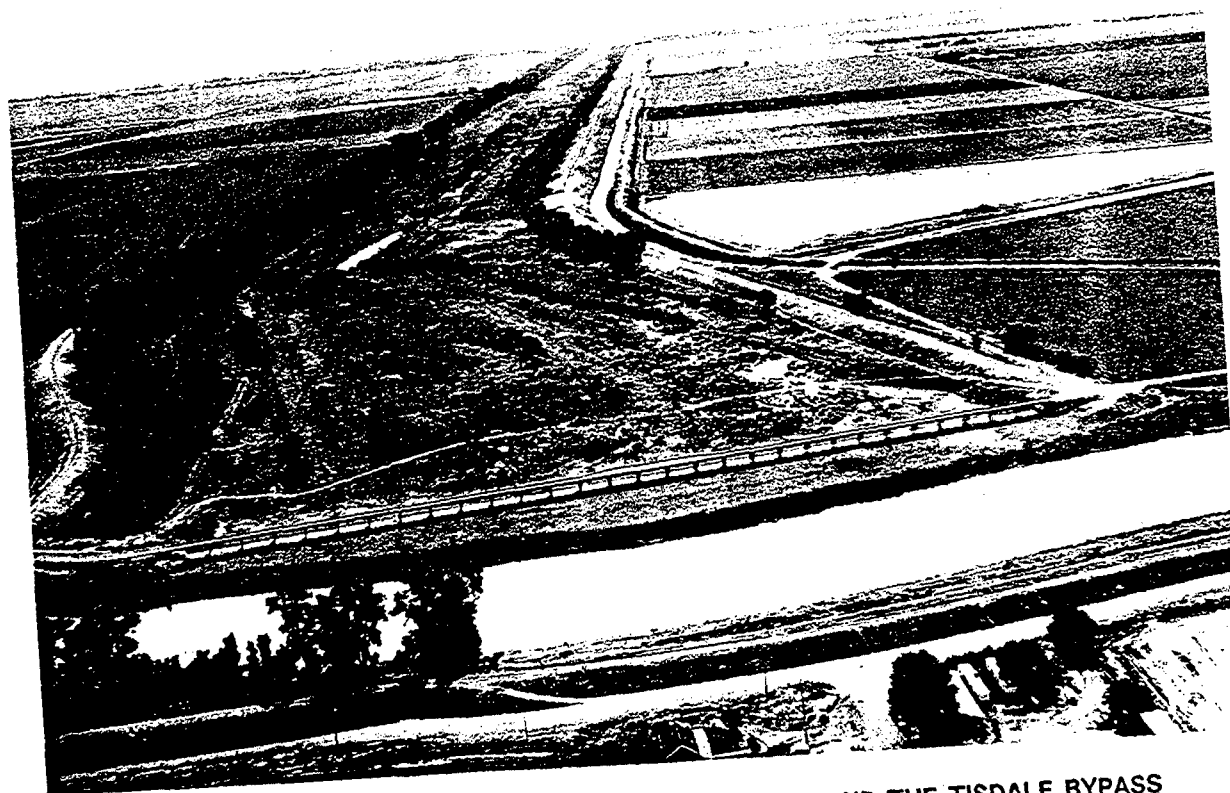
RIVER MILE 118 - ENTRANCE TO THE TISDALE WEIR AND THE TISDALE BYPASS
15 JULY 1982.

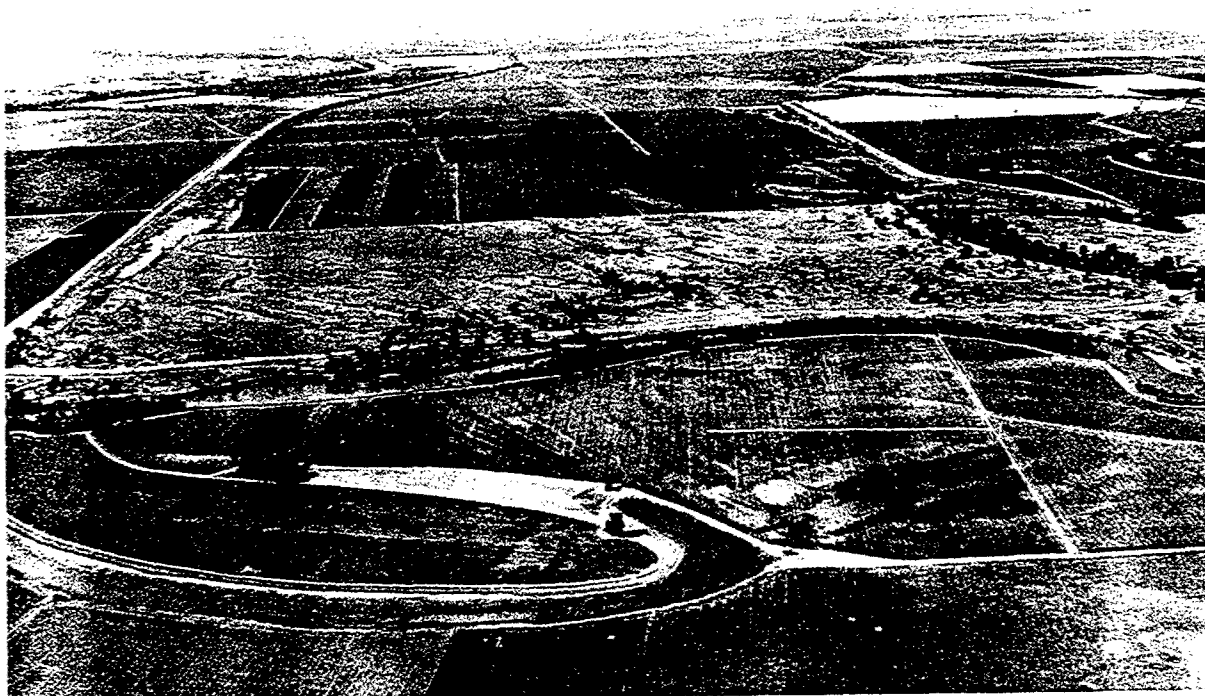
RIVER MILE 82 - ENTRANCE TO THE FREMONT WEIR AND YOLO BYPASS
15 JULY 1982.

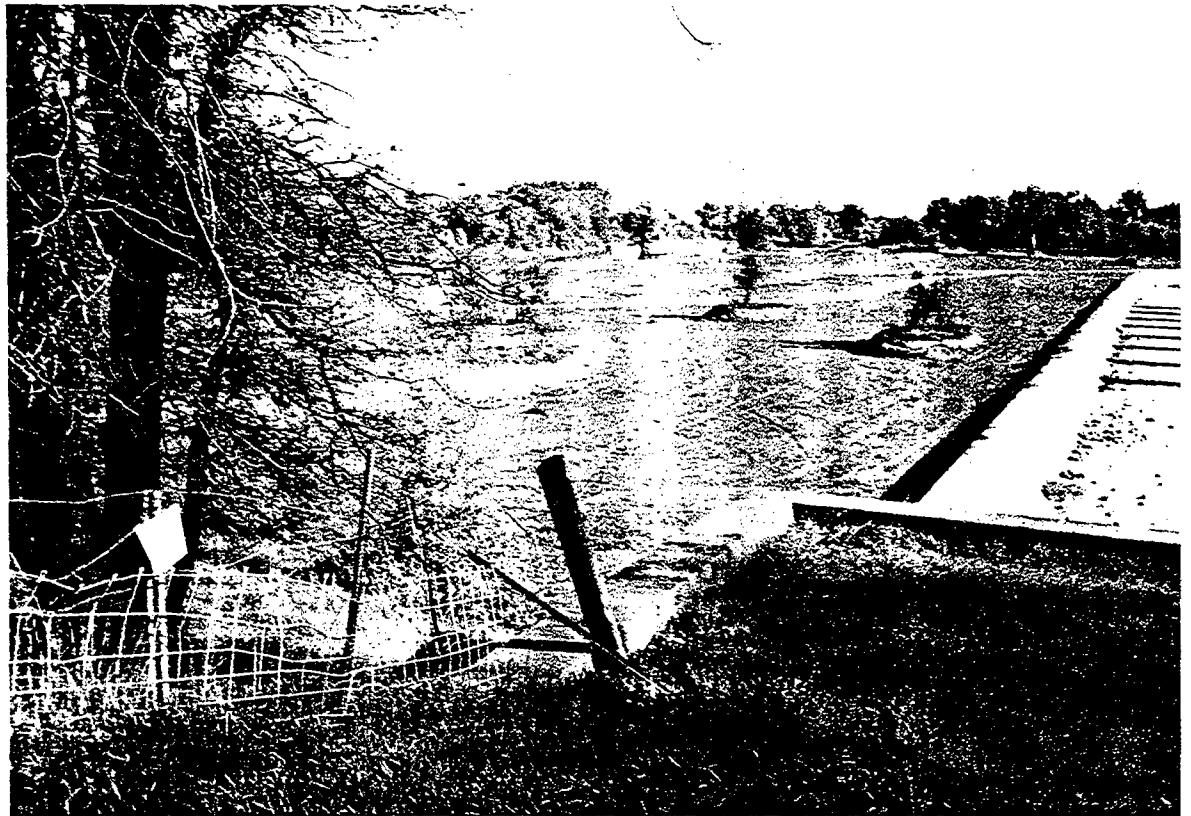
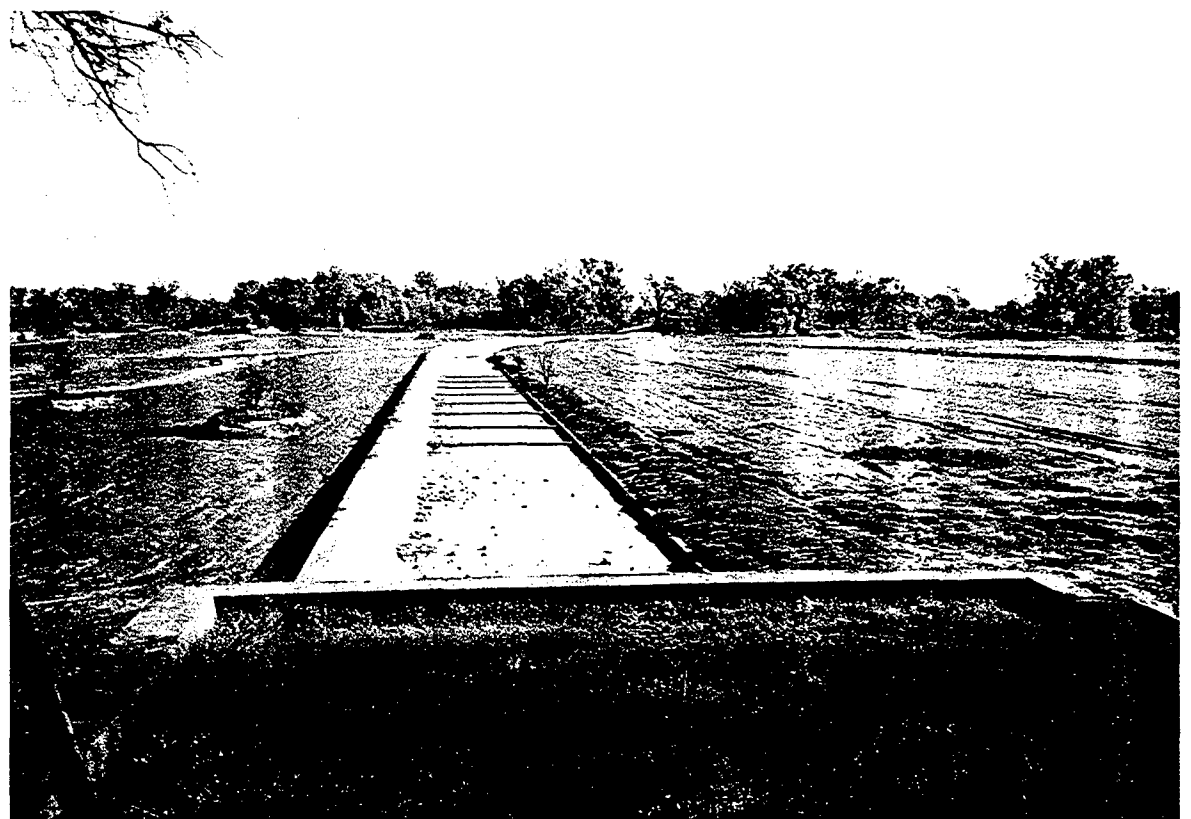
ACCUMULATED DEBRIS AND SEDIMENT IN VICINITY OF FREMONT WEIR WAS
REMOVED BY STATE AFTER FEBRUARY 1986 FLOOD.

In 1986 (following the February flood event), 1987, and 1991, the State (DWR) removed accumulated sediments near Fremont Weir (see Figure 19). Evaluations by the Corps of Engineers indicate that the sediment removal does not improve the flow conveyance over the weir during flood conditions. This is due to backwater conditions in the Yolo Bypass downstream from Fremont Weir. The hydraulic and hydrologic modeling efforts simulating existing conditions at the weir (with the sediment removed) were used in developing the stage-frequency relationships in the vicinity of and downstream from the weir. Under existing conditions, the 1986 water surface elevations correspond to a 60-year recurrence interval on Sacramento River near Knights Landing (Figure 6), a 50-year recurrence interval on the Sacramento River at Fremont Weir (Figure 7), a 60-year recurrence interval on the Sacramento River near the Natomas Cross Canal (Figure 8), a 50-year recurrence interval on the Sacramento River near Sacramento Bypass (Figure 9), and a 55-year recurrence interval on the Yolo Bypass just downstream from Cache Creek (Figure 14).

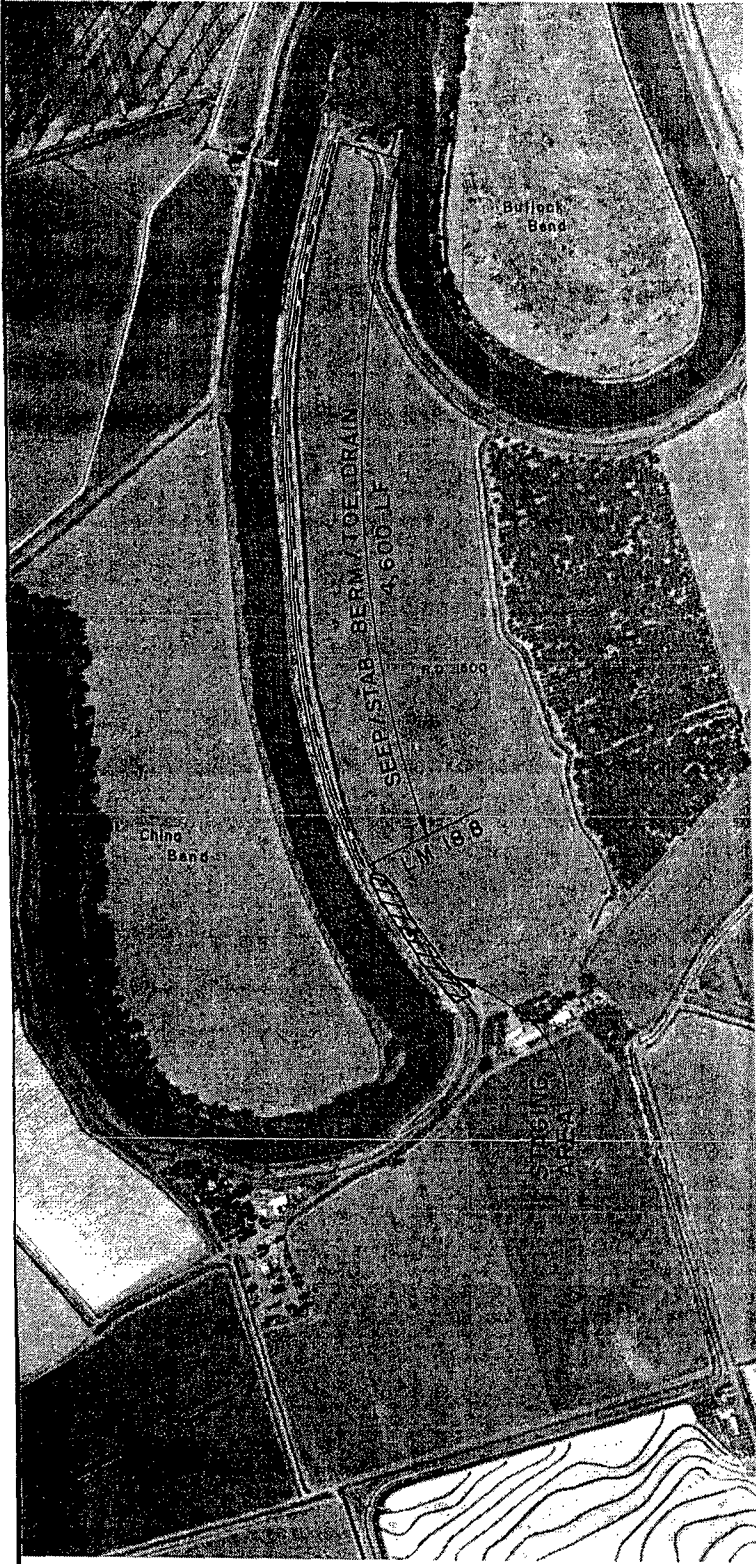
LEVEE RECONSTRUCTION SITE 6

SITE 6

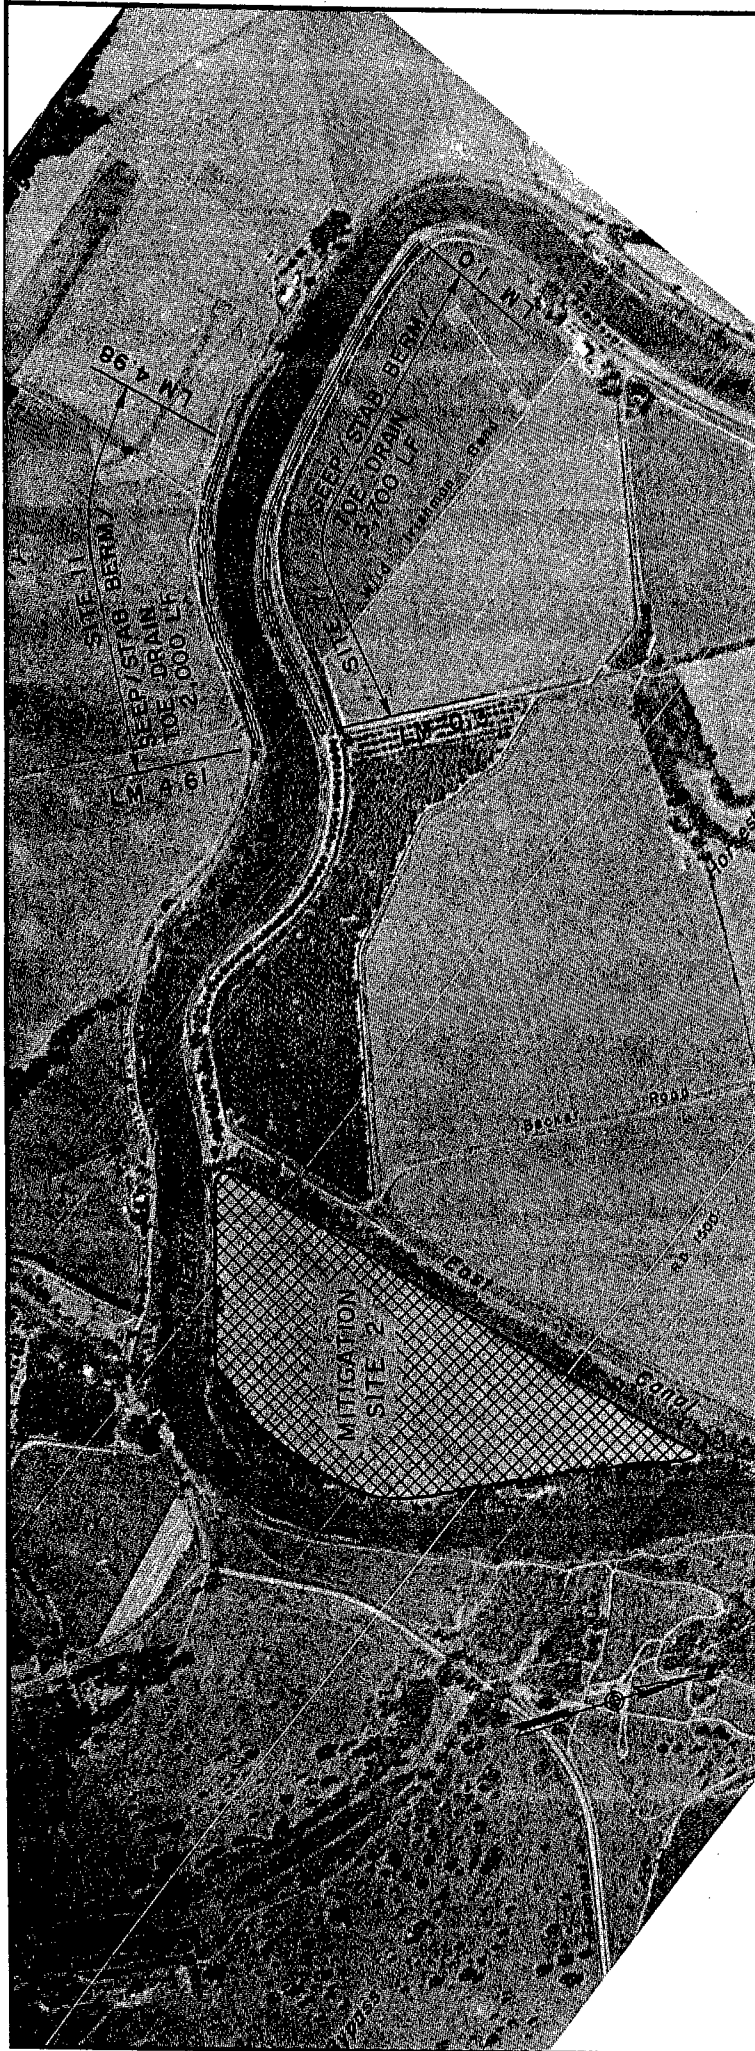
**LEVEE RECONSTRUCTION
SITES 7 & 8**

SITES 7 & 8
SCALE 1"= 800'

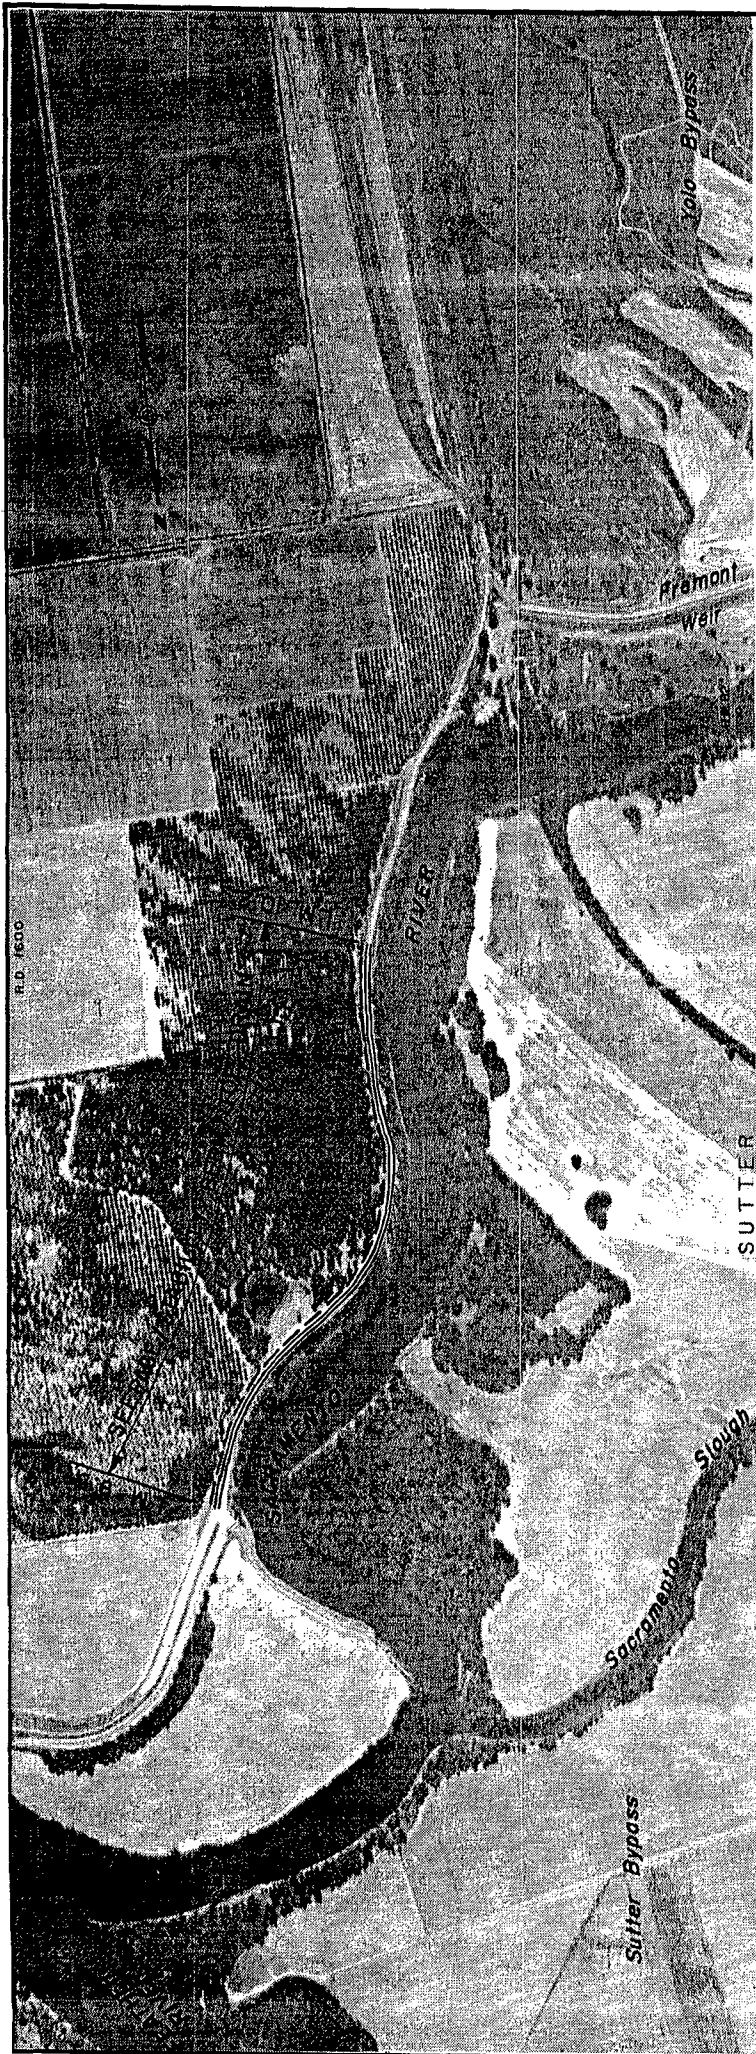
LEVEE RECONSTRUCTION
SITE 14

SITE 14
